Review Article

The Vajont Landslide: an overview of 60 years of research

Abstract: The Vajont Landslide, one of the most catastrophic events in history, has been extensively studied for over 60 years. Navigating the extensive Vajont literature presents challenges due to the volume of information, persistent questions, ongoing controversies, and even unreliable information. This review offers a novel synthesis by identifying the most influential hypotheses through the lens of updated geomorphological reconstructions, evolving interpretations of the sliding surface, and conflicting assumptions. It highlights how certain long-held assumptions may have led to biased conclusions, presents a concise dataset of key geotechnical parameters, and stresses the need for future analyses that integrate rainfall and reservoir effects over time, account for possible progressive strength degradation, and revisit slope stability under more realistic boundary conditions. By clarifying closed questions and spotlighting persistent uncertainties, this paper aims to guide future research and reframe understanding of the Vajont landslide.

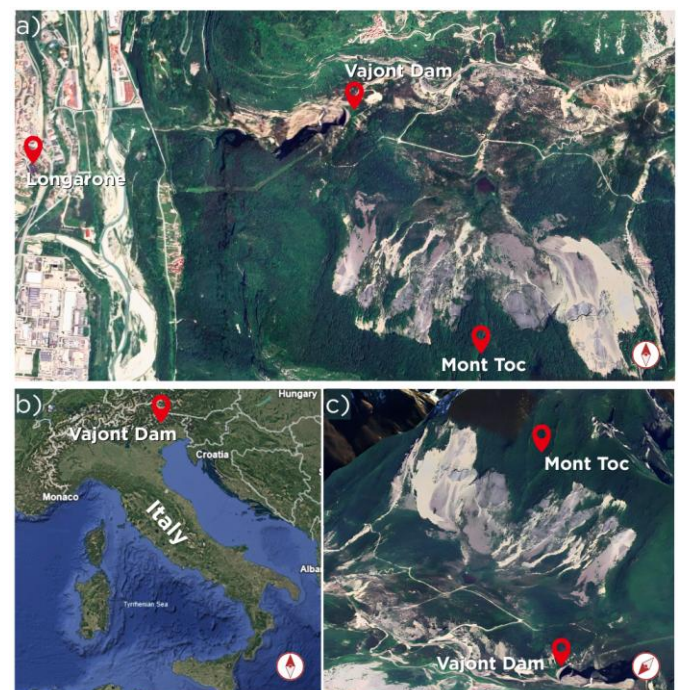
Figure 1. (a) Satellite image showing the Vajont valley with Longarone, Vajont Dam, and Mount Toc. (b) Location of the Vajont Dam in north-eastern Italy. (c) Perspective view of Mount Toc and Vajont Dam (Images obtained from Google Earth).

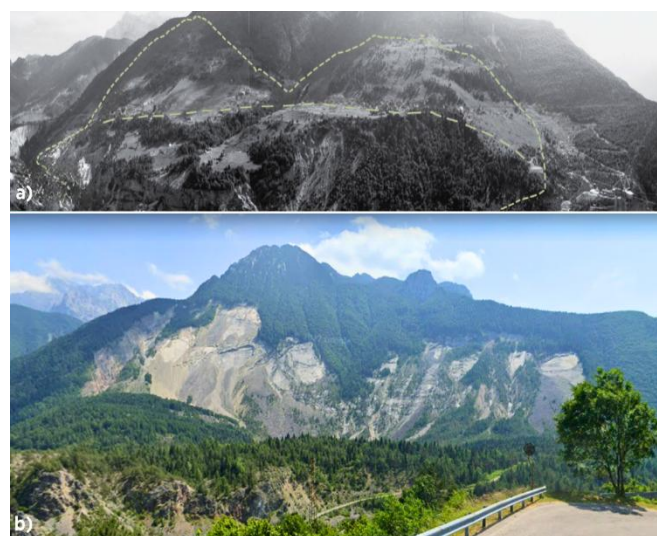
Figure 2. Monte Toc a) before the 1963 failure (photo by Edoardo Semenza, available at http://www.k-flash.it/mostra_vajont/2.html) and b) after the failure, showing the detachment surface (Image obtained from Google Earth)

exceeded 100 meters in height above the crest of the dam. The failed rock mass, with a thickness of approximately 250 meters, traveled horizontally for about 300 meters, mainly maintaining its shape except for overall rotation. The extremely high velocity and the en masse movement of the Vajont landslide were not only surprising but remain incompletely understood to this day.

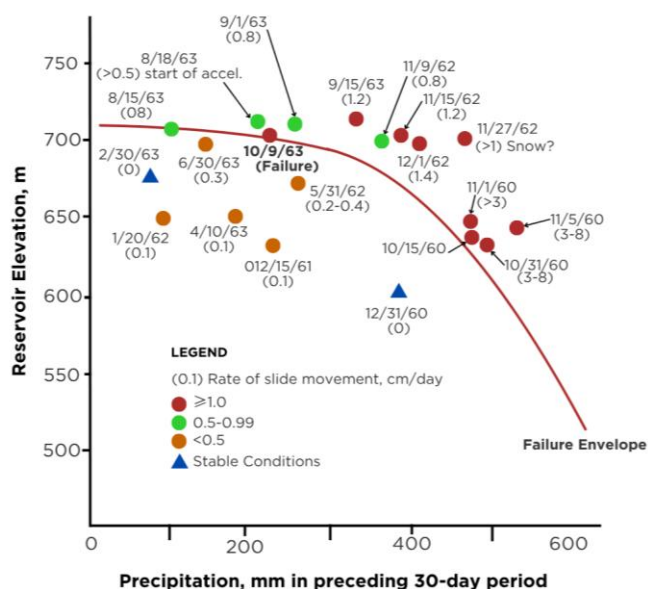
Figure 11. Reservoir water level versus precipitation (averaged over the preceding 30-day period) (modified from [9]).

- 1) By plotting the water level in the reservoir versus the recorded precipitation data, Hendron and Patton [9] drew a boundary between the stable and unstable combinations of the slope, creating a “failure envelope,” which suggests that the slide was caused by the combination of the effects of both rainfall and the impounded reservoir (Figure. 11). However, the final movements would also have occurred due to raised pore water pressure regardless of their primary origin. The water level in the reservoir could have caused enough uplift pressure to trigger the slide if it had reached its full supply level of 722.5m, even without any rain or snowmelt; at the same time, very high levels of precipitation, in the magnitude range of 130 to 200 percent of the 7 to 45-day precipitation recorded for 1960 to 1964, would have been enough to cause the failure even without the presence of any reservoir.
